Research Article

Technical evaluation of selected soil conservation practices and farmers' perception about soil erosion in Donbi Watershed, Wolaita Zone, Southern Ethiopia

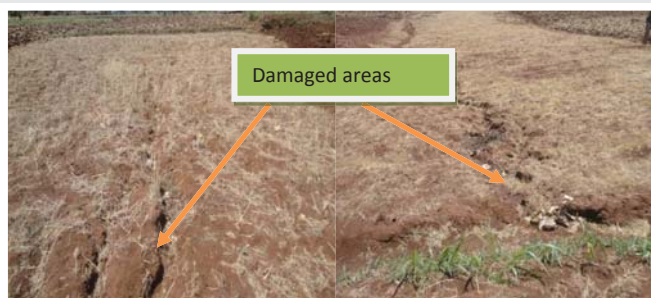
In the upper and middle sections of the watershed, it was observed that stabilization increased the sustainability of the bunds. In about 71% of the selected farm plots, rills of various sizes were observed (Figure 1). However, in about only 32% of the farmlands the damage of various levels was observed in different sections of the bunds. Therefore, damage to the bunds was not as such the erosion in the farmlands.

Figure 1: Soil erosion in some of the farm plots the watershed.

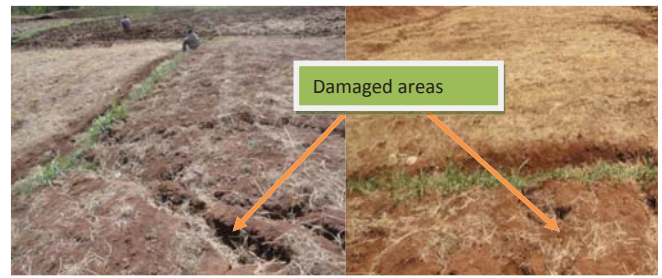
However, in downstream parts of the watershed the cases were different. In about 42.9% of the selected farm plots, bunds had damage of various levels (Figure 2). Regarding erosion features in the farm plots, it was higher than both up and middle stream parts of the watershed. About 71s% of the selected farm plots had rill erosion problem and of them in about 40% rills of large size were observed. This could be related with wider spacing of the bunds than the recommended ones as indicated in previous sections.

Figure 2: Damage to soil bunds in some of the farm plots in the watershed.
